SAVERY POND EAST BOG HYDROGEOLOGIC RECONNAISSANCE INVESTIGATION

MAY 2020

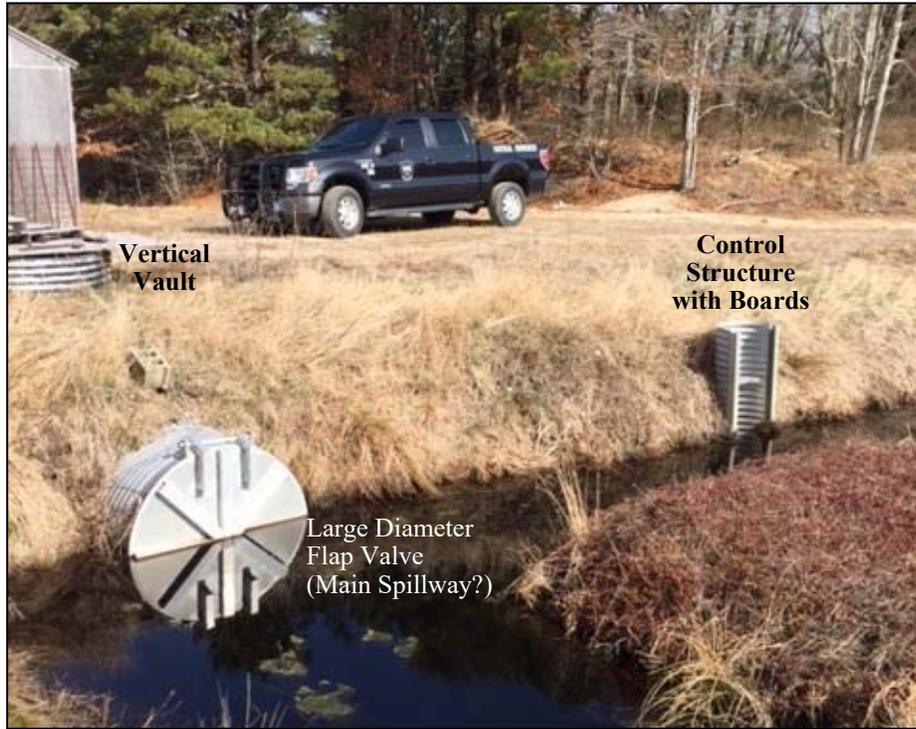
Control Structures on Perimeter Ditch

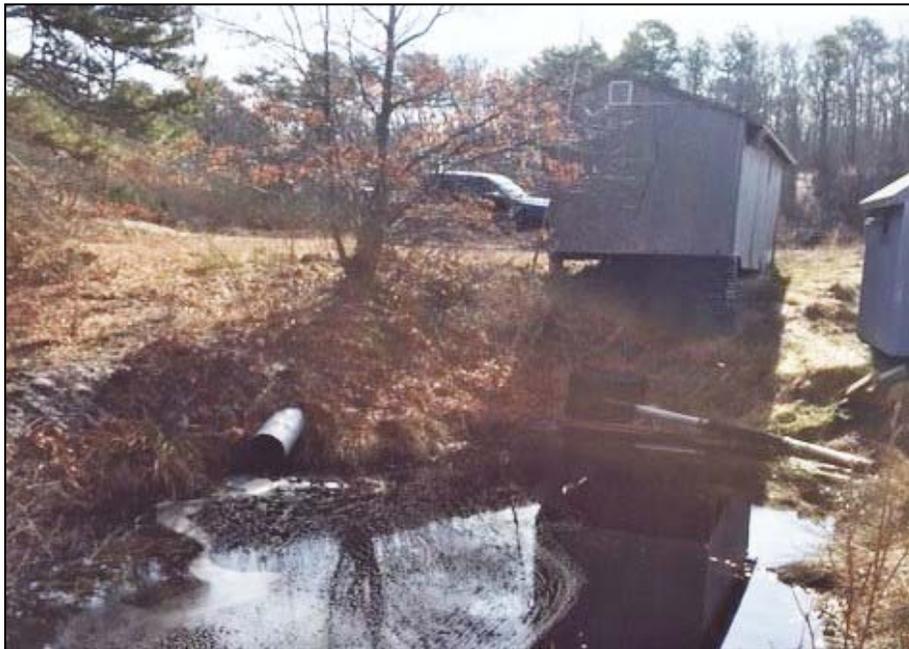
Figure 2
Water-Control Infrastructure at East Bog

- A smaller-diameter (e.g. 16-inch) discharge pipe that extends from the canal to the perimeter ditch (location S-4 on **Figure 1**). This corrugated pipe is capable of conducting drainage from the bog ditches into the canal.

Discharge Pipe (left) and Abandoned Pump Intake (right) on Savery Pond Canal

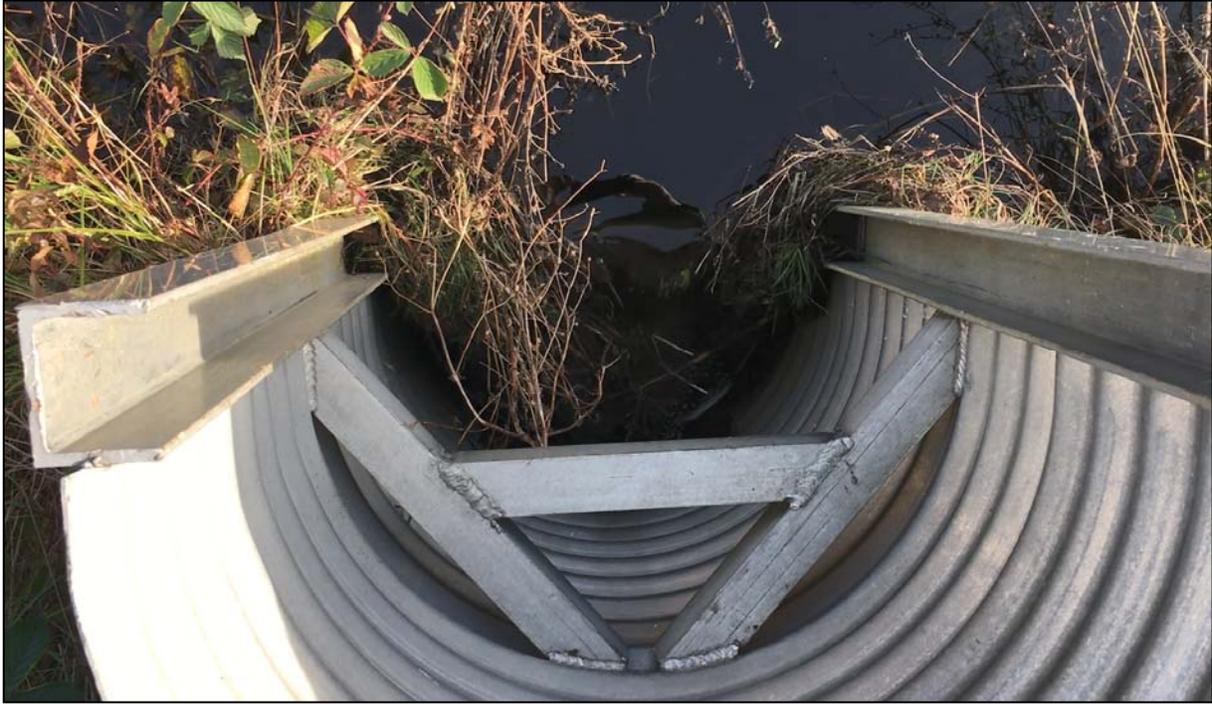
Water from Ditch Overtopping Control Board and Flowing into Small Culvert (12/2/18)

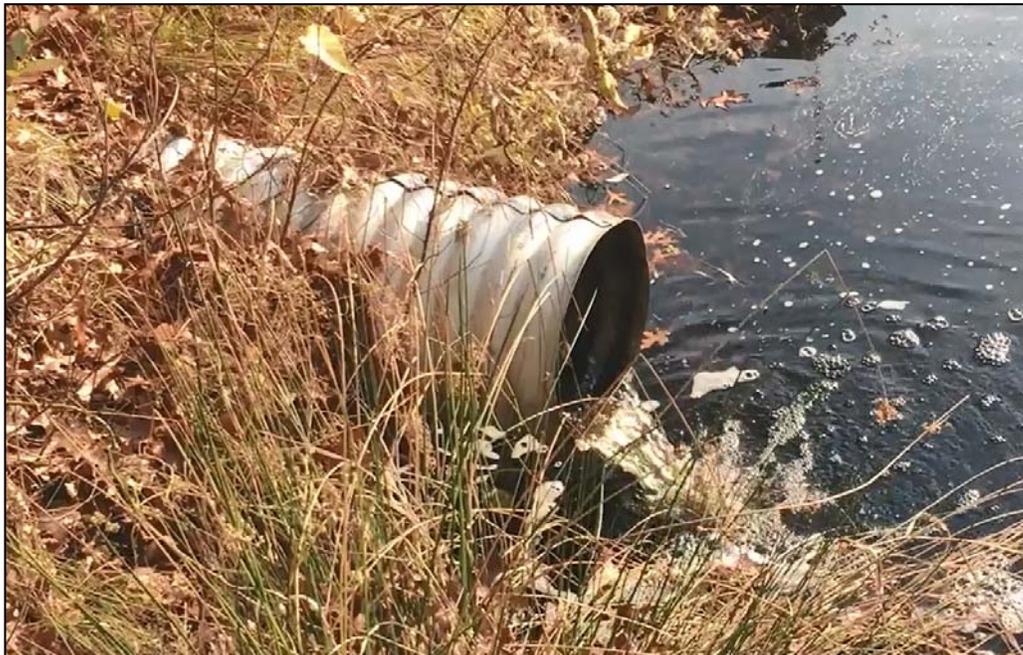
Figure 4
Water Discharge from Bog to Pond Canal

Pipe Outflow into Savery Pond Canal (12/2/18)
